# **Intel® Mobile Celeron™ Processor Specification Update**

Release Date: June 1999

Order Number: 244444-005

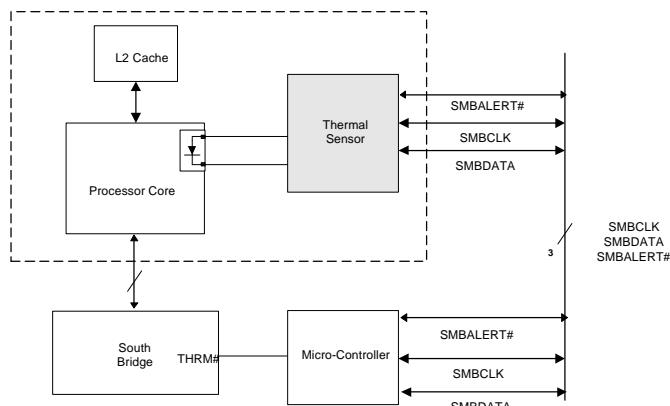
Figure 1. An Example of Microcontroller Driven Thermal Management

**PROBLEM:** The Intel Celeron Processor Mobile Module has a thermal sensor that monitors the processor core's temperature. Please note that desktop systems could have a similar thermal device. The thermal sensor asserts SMBALERT# if the processor temperature exceeds the temperature limits set in the Alarm Threshold Registers ( $T_{HIGH}$ ,  $T_{LOW}$ ). It also sets the corresponding Status Register bits to identify the cause of the interrupt. Figure 1 gives one example of the how the SMBALERT# signal could be used in a system.

Under the conditions described below, the thermal sensor incorrectly generates the SMBALERT# interrupt. *All* of the following conditions must be met to trigger a false interrupt:

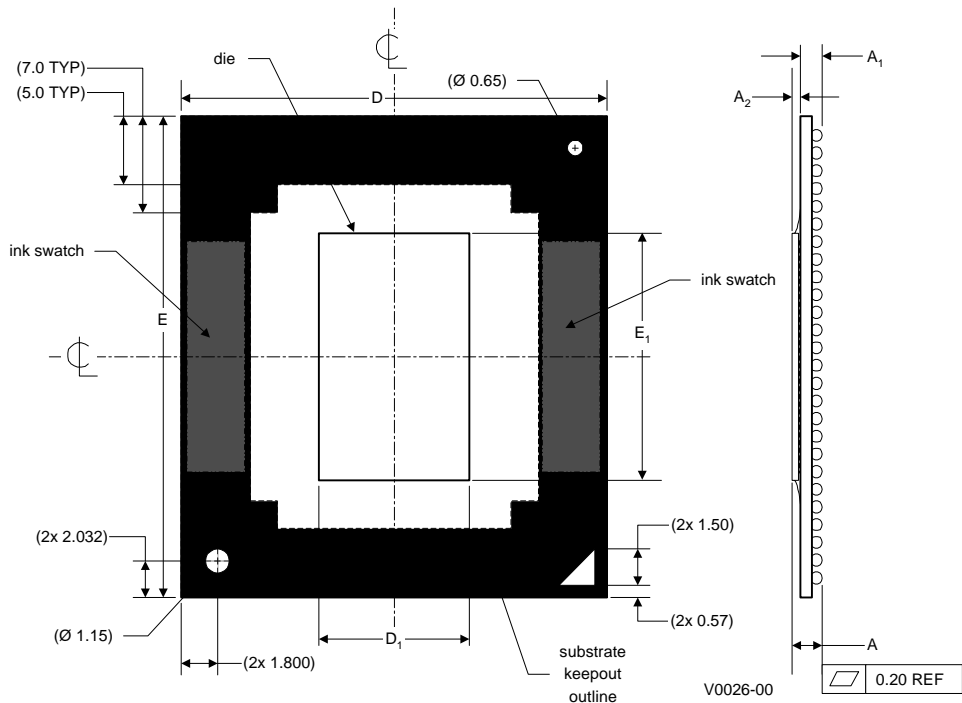
**Figure 5.3. Surface-Mount BGA1 Package - Top and Side View**

The following table and figures show the updated mechanical specifications for the BGA1 package, listed as Table 5.2, Figure 5.3 and 5.4, respectively, in the *Intel® Mobile Celeron™ Processor in BGA Package at 333 MHz, 300 MHz and 266 MHz* datasheet.
